## URGENT WELD BULLETIN

Cottrell, Inc. has received reports that there has been some confusion on the SB006 bottom gusset welding procedures on the C-10LTA and C-10LTB trailers. Please see photos below of examples of the correct and incorrect weld procedure for this area. Picture A shows the correct weld procedure for welding the top of the gusset to the front post. Picture B demonstrates an improper installation with a weld missing at the top of the gusset, and also demonstrates improper wrapping of the weld at the corner of the gusset. Attached is a drawing showing the correct welding procedures and weld locations. If you currently own a C-10LTA or C-10LTB trailer, or if you have performed the SB006 update on a customer's C-10LTA or C-10LTB trailer please inspect immediately. If not properly welded, please contact Kris Ransom at 800-827-0132 ext 301 for a resolution.

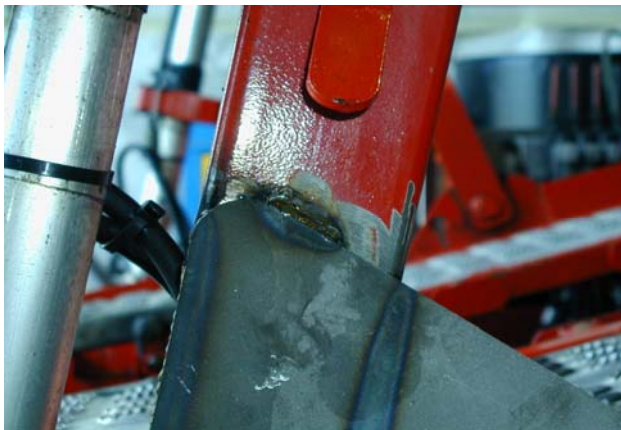
PICTURE 'A'

CORRECT

- 2 1/2" weld at top of gusset
- No wrapping of welds in corners

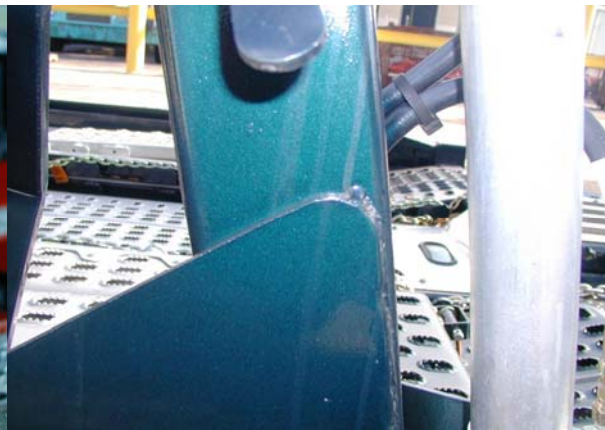
PICTURE 'B'

INCORRECT

- No weld at top of gusset
- Weld wrapping corner of gusset
