URGENT WELD BULLETIN

Cottrell, Inc. has received reports that there has been some confusion on the SB006 bottom gusset welding procedures on the C-10LTA and C-10LTB trailers. Please see photos below of examples of the correct and incorrect weld procedure for this area. Picture A shows the correct weld procedure for welding the top of the gusset to the front post. Picture B demonstrates an improper installation with a weld missing at the top of the gusset, and also demonstrates improper wrapping of the weld at the corner of the gusset. Attached is a drawing showing the correct welding procedures and weld locations. If you currently own a C-10LTA or C-10LTB trailer, or if you have performed the SB006 update on a customer's C-10LTA or C-10LTB trailer please inspect immediately. If not properly welded, please contact Kris Ransom at 800-827-0132 ext 301 for a resolution.

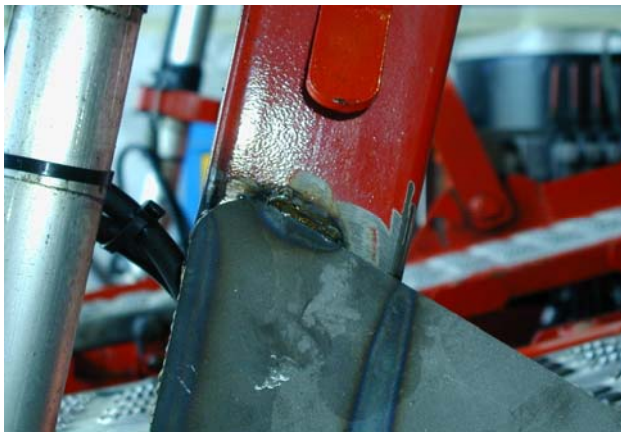
PICTURE 'A'

CORRECT

- 2 1/2" weld at top of gusset
- No wrapping of welds in corners

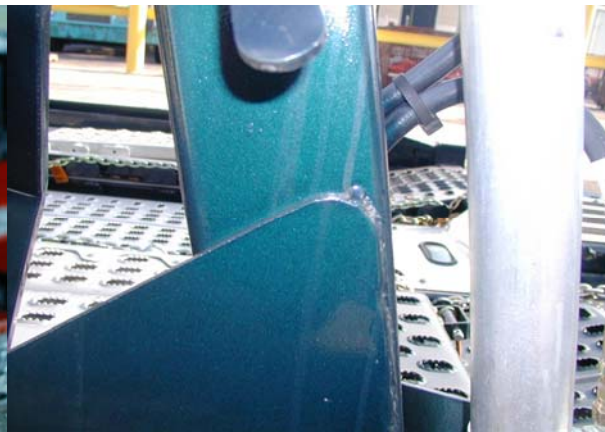
PICTURE 'B'

INCORRECT

- No weld at top of gusset
- Weld wrapping corner of gusset

Review following drawing, #111541, for correct welding specifications and procedures.

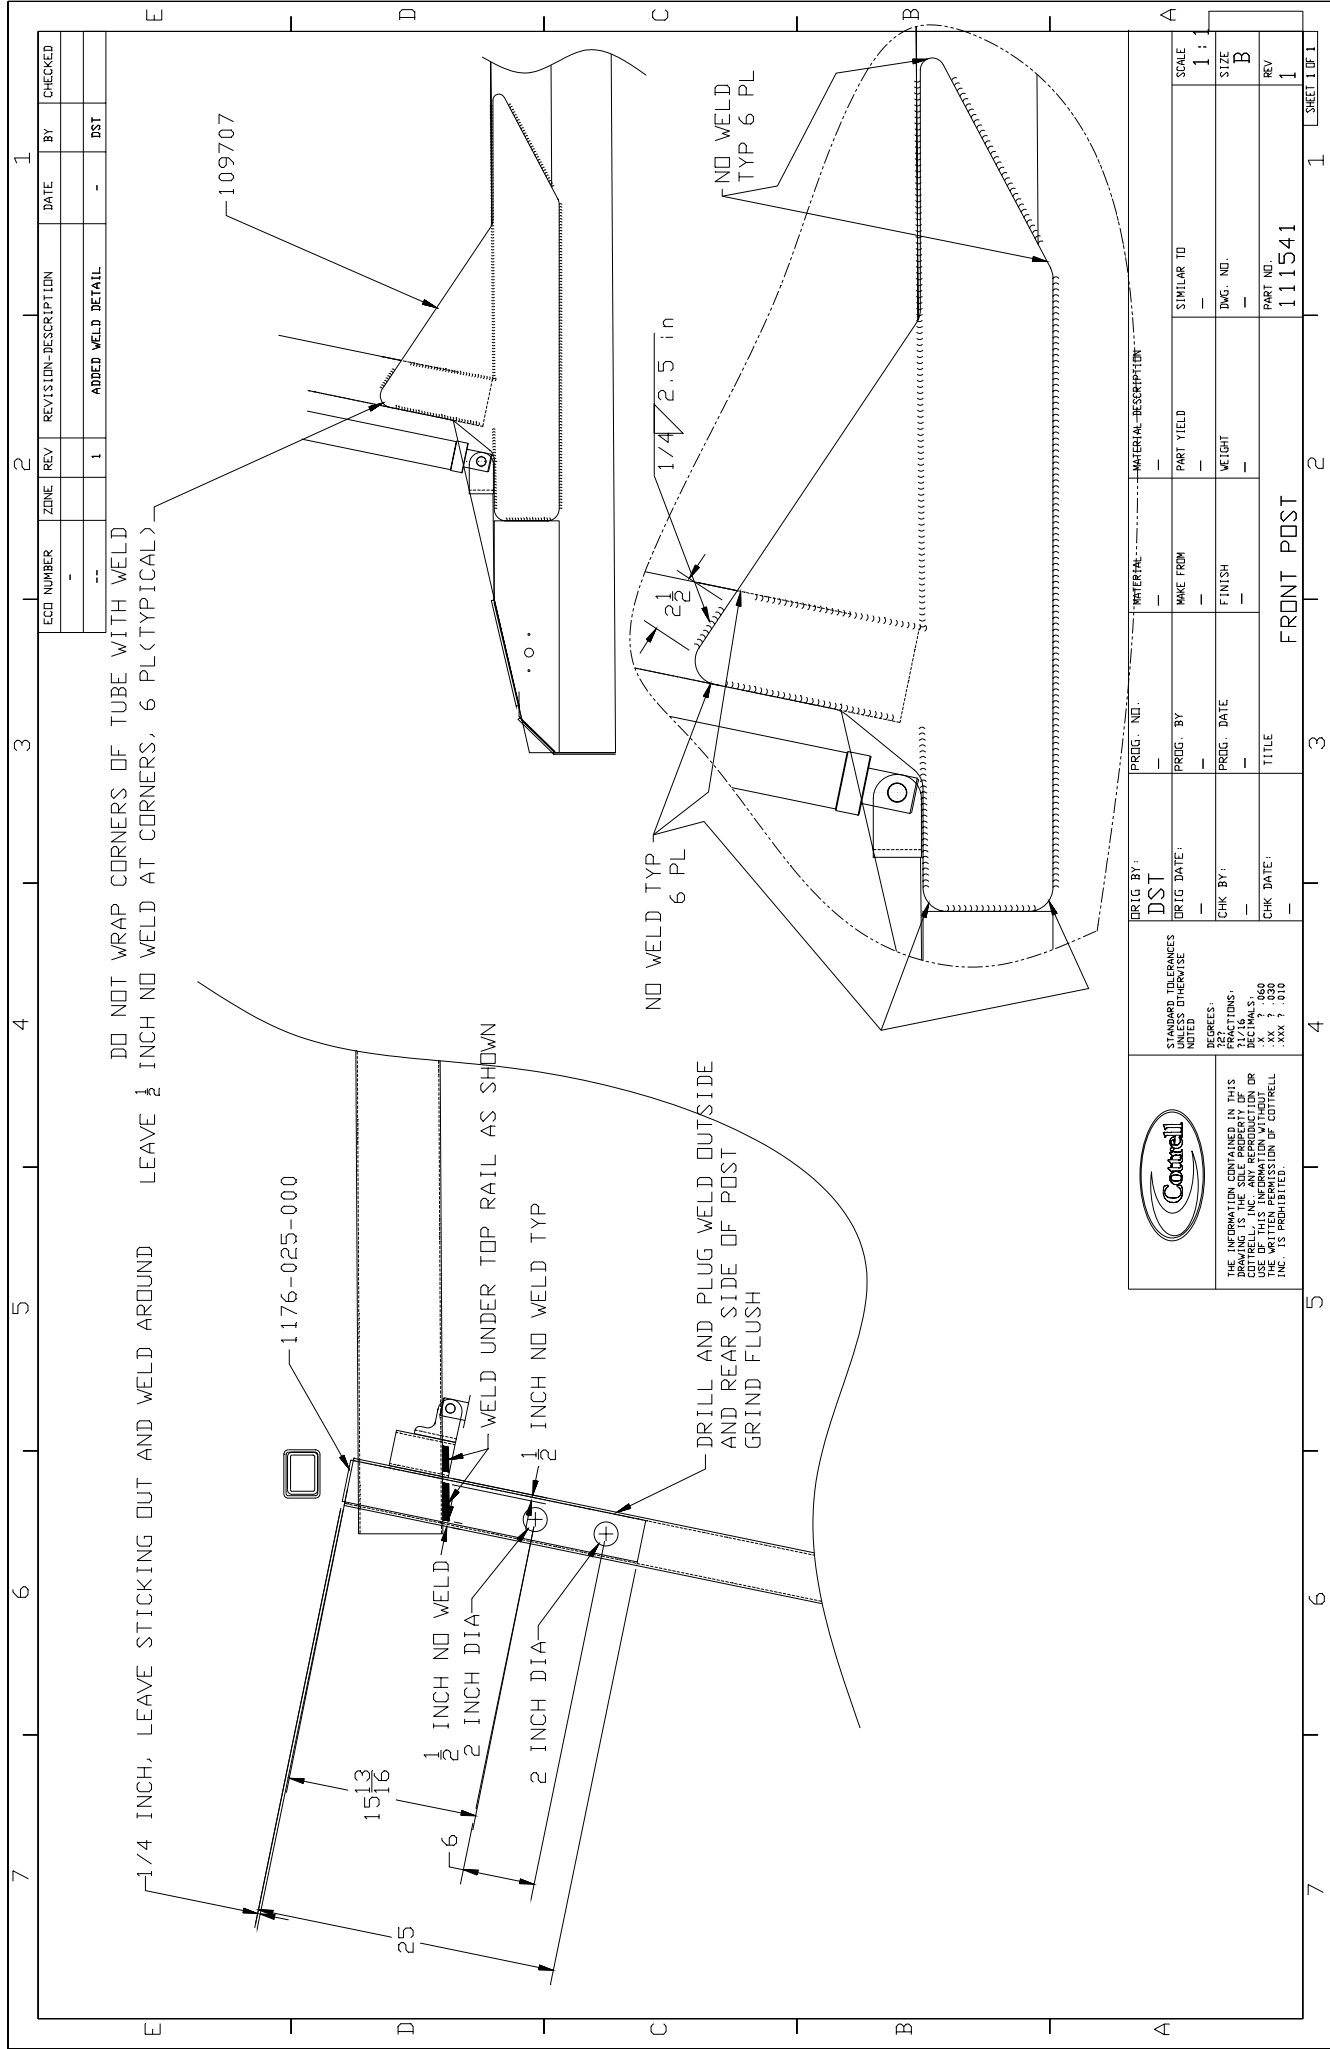
DO NOT WRAP CORNERS OF TUBE WITH WELD
LEAVE 1/2 INCH NO WELD AT CORNERS, 6 PL(TYPICAL)
