Service Bulletin #SB012

Subject: Trailer Skid Roller Flange Bolts

Models Affected: Strap Units With Production/Conversion Dates Between May 2010 and Mid-November 2011 Having Certain Configurations of the Bottom, Rear-Most Deck of the Trailer

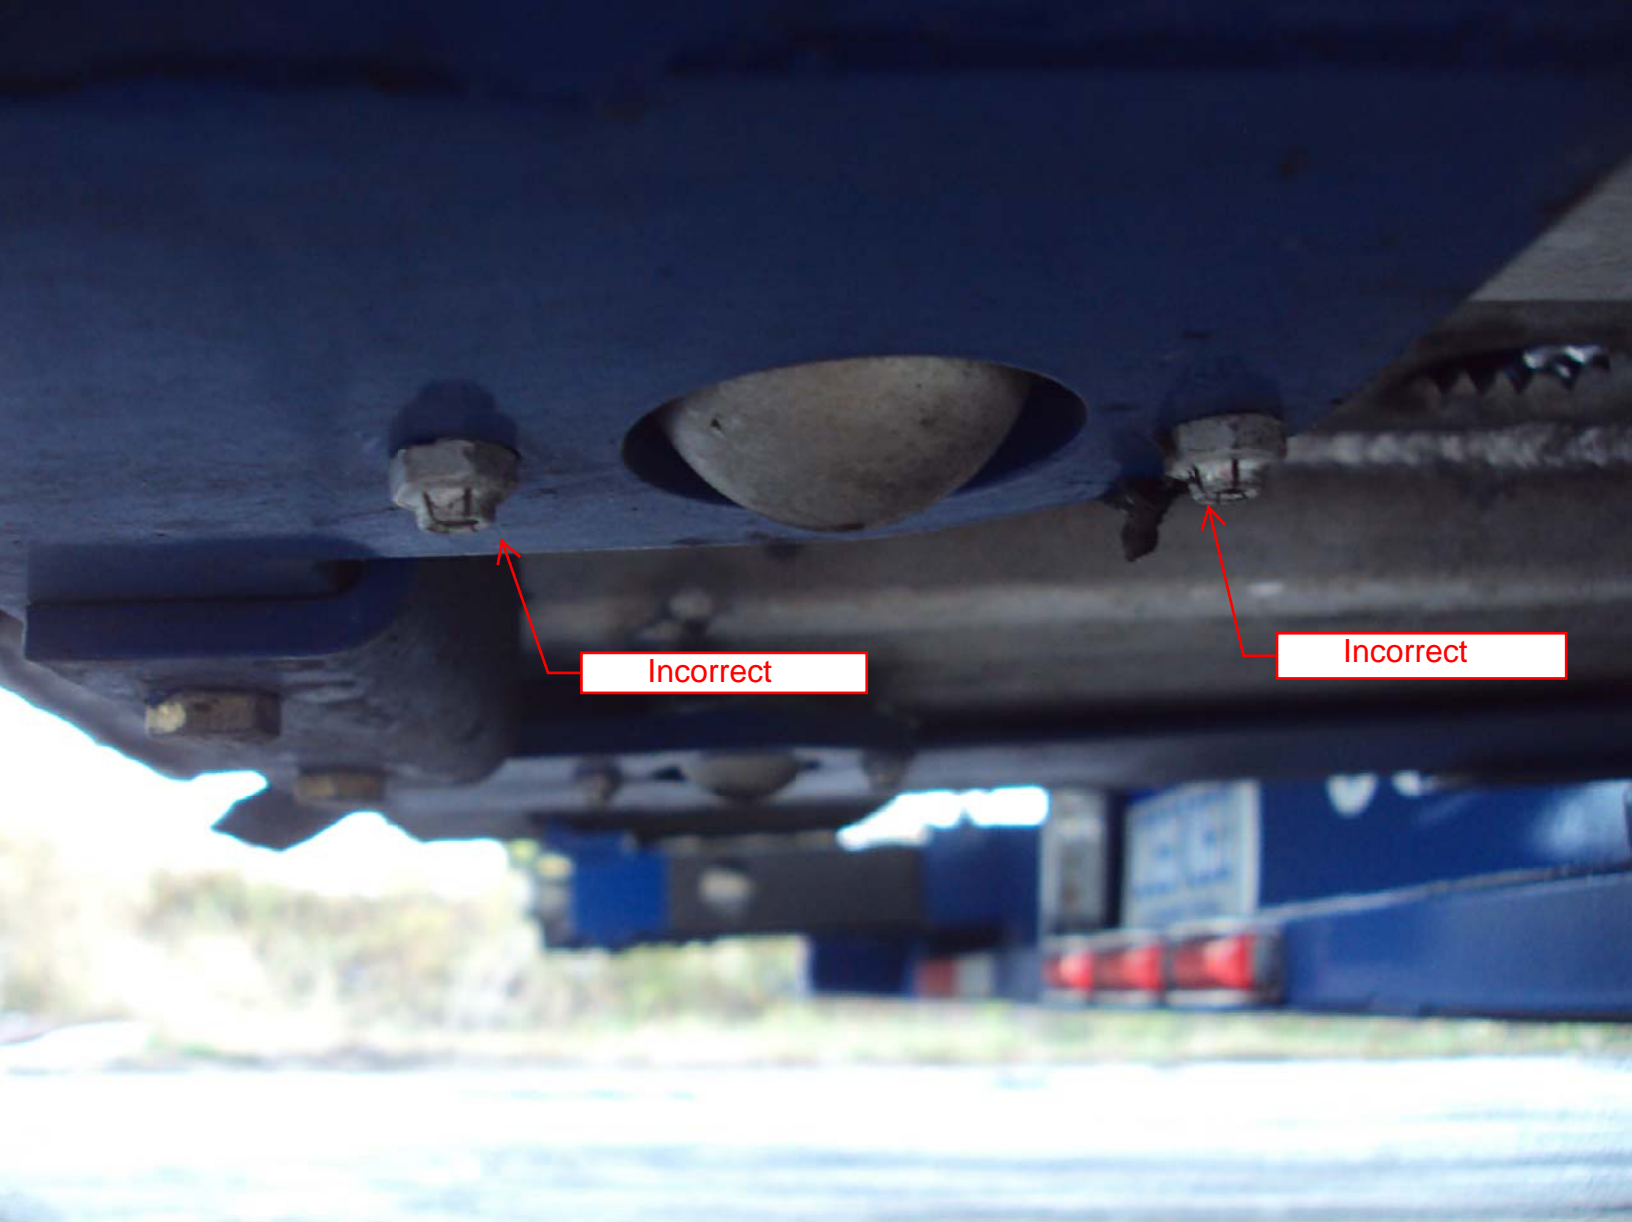
Incorrect

1. See enclosed photographs.
2. Inspect skid transfer ball flanges inside loading skid pocket on the rear-most deck of the trailer to see if skid ball flanges and skid ball are still intact.
3. If parts are missing, replace missing parts using the longer bolts as indicated below.
4. If all parts are intact, but bolts are less than $\frac{3}{4}$ inch long, replace the existing (shorter) bolts with 10 x 24 x $\frac{3}{4}$ bolts and Flex Lock nuts as seen on the enclosed photographs.

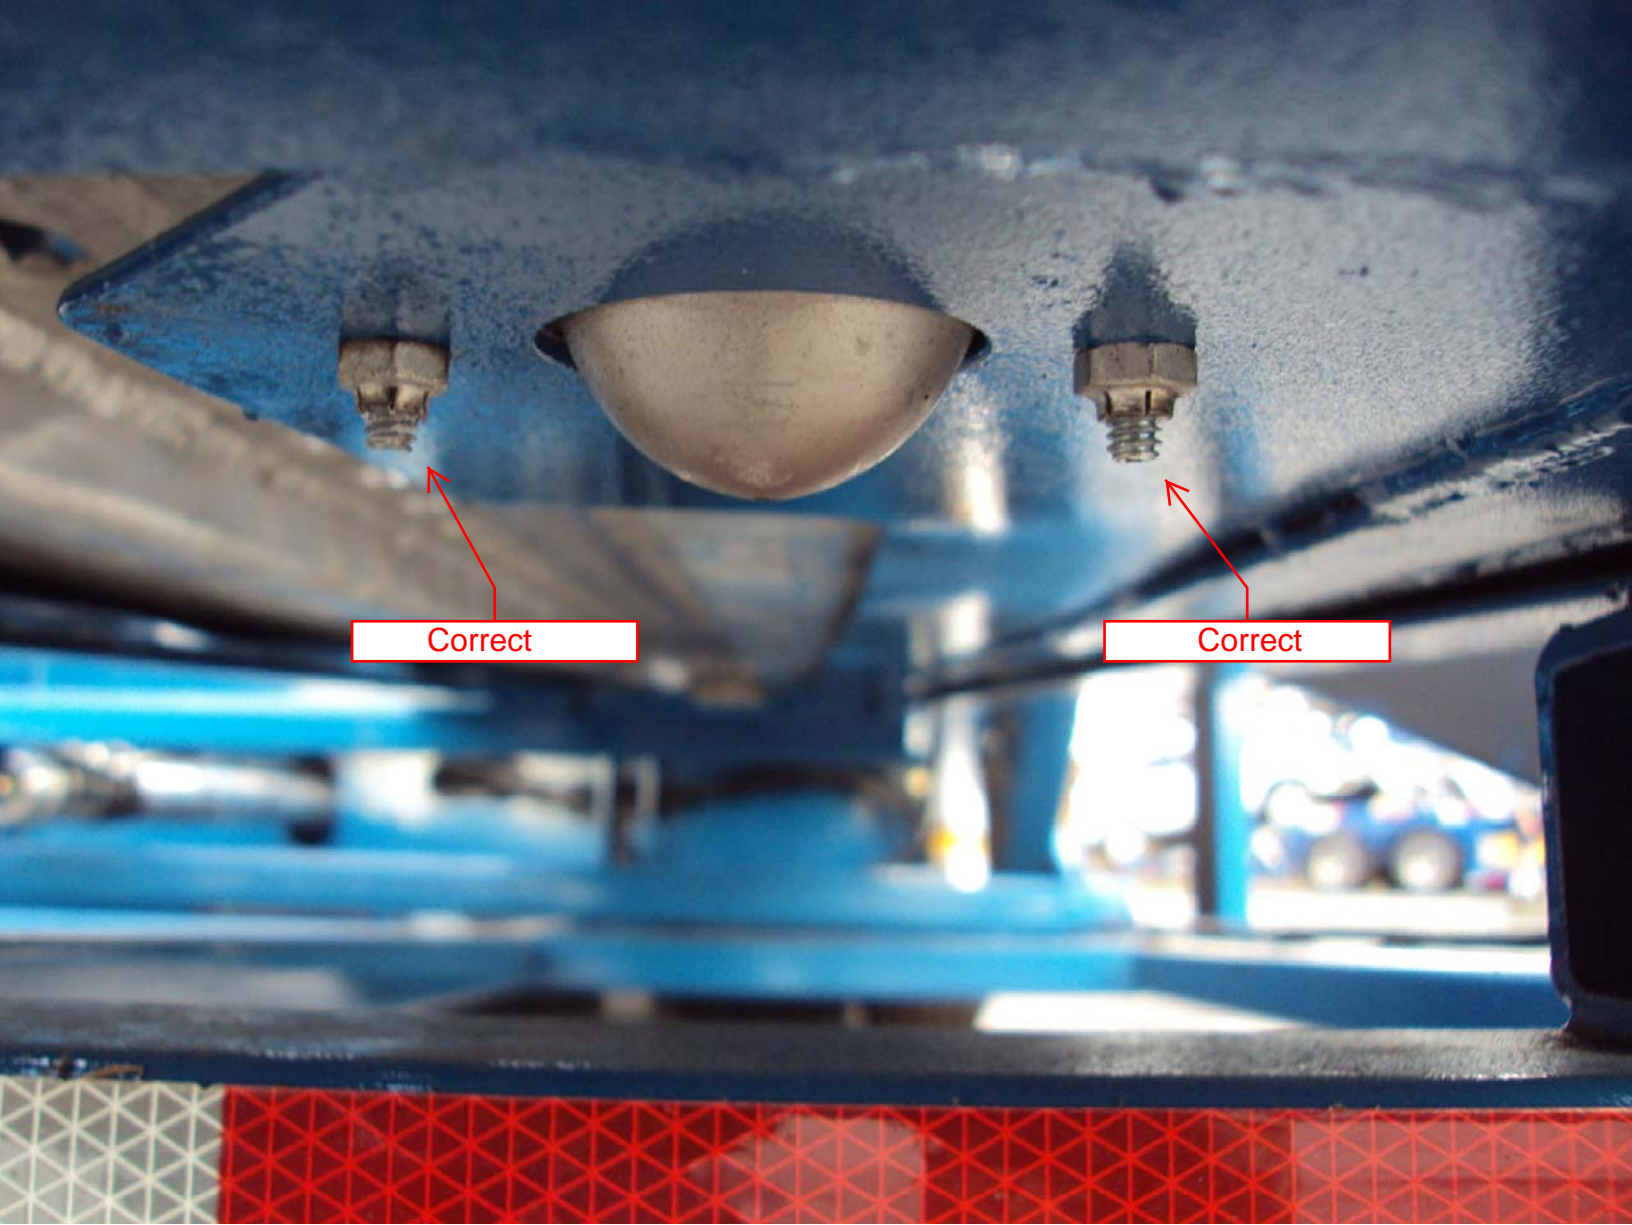
Correct

1. Quantity of 8, 10 x 24 x $\frac{3}{4}$ machine bolt
2. Quantity of 8, 10 x 24 Flex Lock Nut
