May 17, 2019 Service Bulletin #SB025

Subject: Grab Handle Fasteners Inspection and Replacement (where necessary)

Models Affected: Units listed in enclosed document

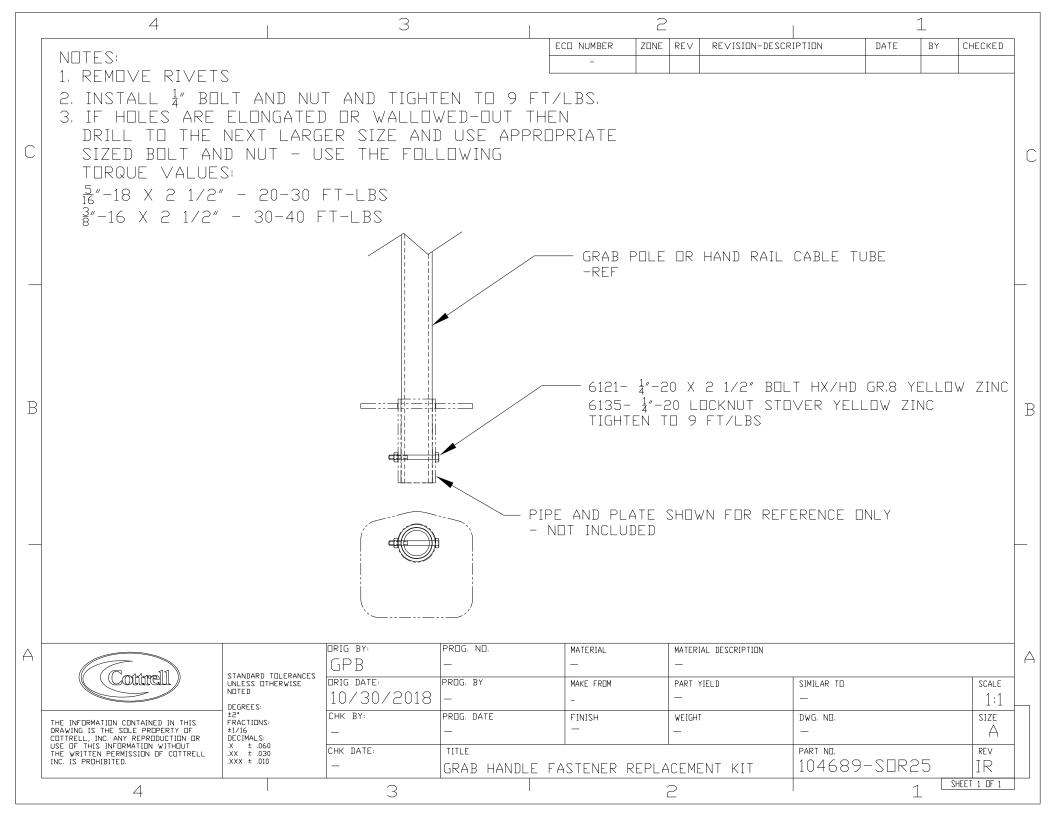
Correct Grab Handle Fastener

- 2. Contact Cottrell with VIN and number of fasteners for grab handles identified as needing rivets to be replaced. You may use your own bolt and nut as long as they meet the specs per drawing#104689-SOR25 supplied with Service Bulletin#025.

- 3. Schedule unit for repairs at the Cottrell Service Center or any Authorized Cottrell Warranty Repair Facility for Service Bulletin #025.
- 4. Have repair center remove rivets from both sides and replace with bolt and nut per drawing#104689-SOR25. If hole(s) have elongated or wallowed out, drill out the holes and install the next larger size bolt using the torque values set forth on the enclosed drawing.

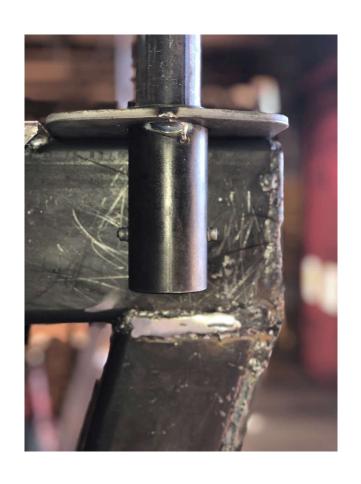
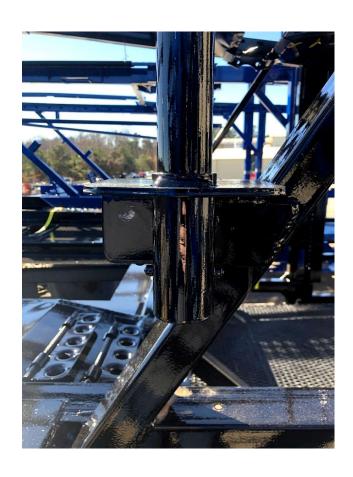
Condition of Rivets - Bad/To Be Replaced

- 1. Inspect all Grab Handle Fasteners on affected units to identify rivet(s) that are loose, missing, sagging, missing the center pin, or otherwise damaged or appearing as though they were not installed correctly. See enclosed photographs to determine condition of rivets.

Loose Missing Sagging Missing center pin
